# **JOHN OXLEY REPORT - END 2022**

2022 has been a huge year for the *John Oxley* restoration and for the Fleet with very significant milestones achieved. For this report, the most important was clearly the refloat of *John Oxley* at Garden Island Dockyard.

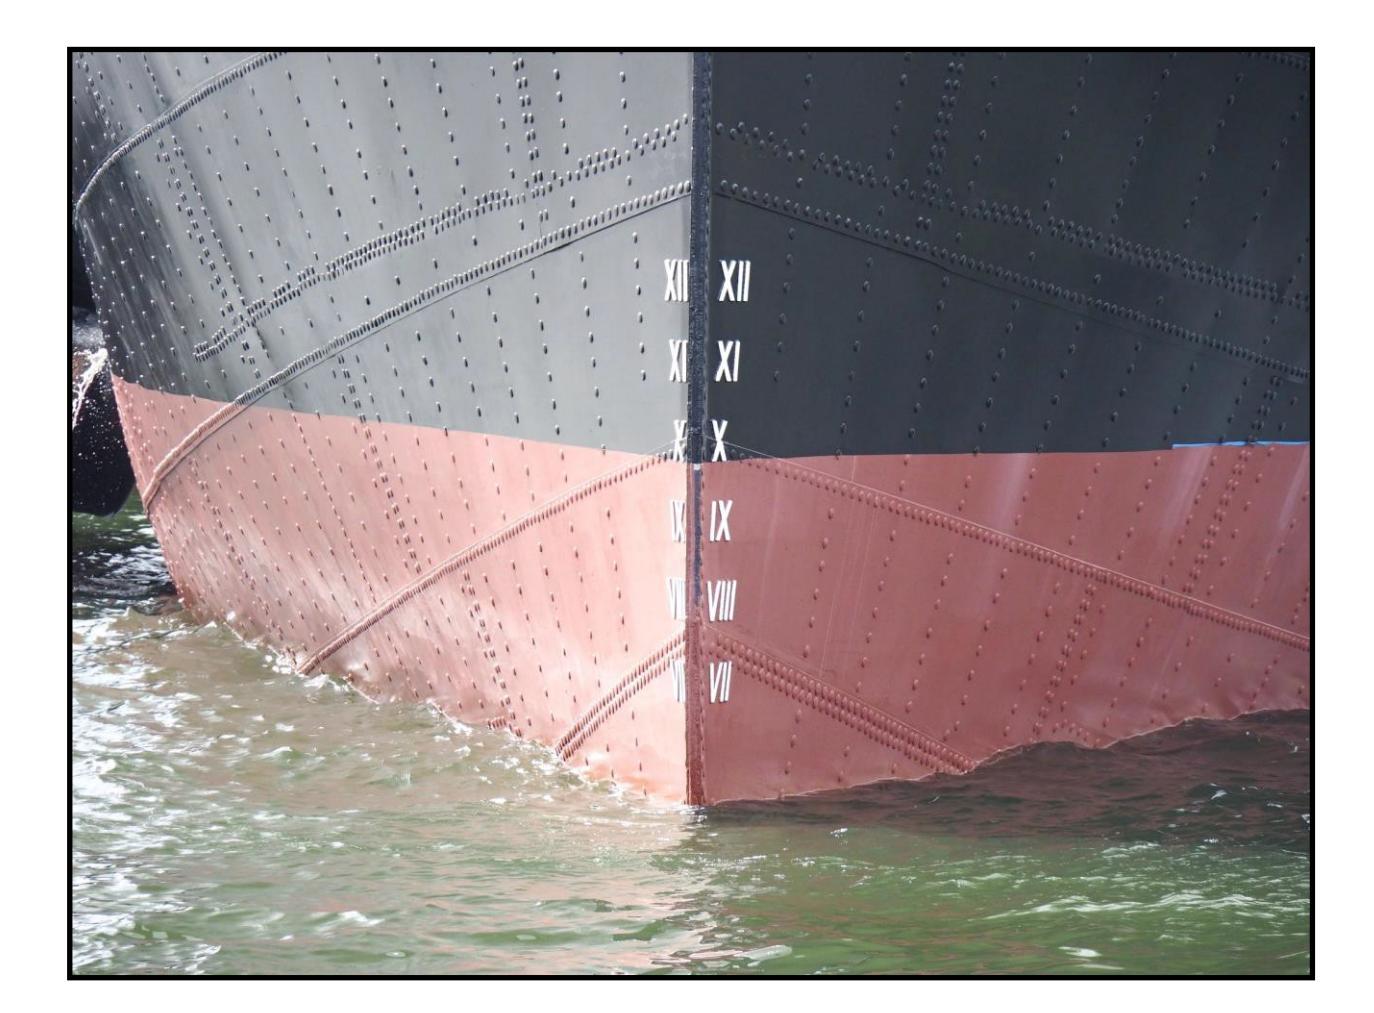
One feature that sets *John Oxley's* hull apart are Roman Numeral draft marks at stem and stern. Today, these marks must be metric, however, special permission was given for these to be traditional Roman Numerals. These were water jet cut in steel plate and their exact positions were determined by one of our volunteers (retired marine surveyor) whose work our surveyors would accept – Last task was to weld these to the hull and then pick them out in white enamel.

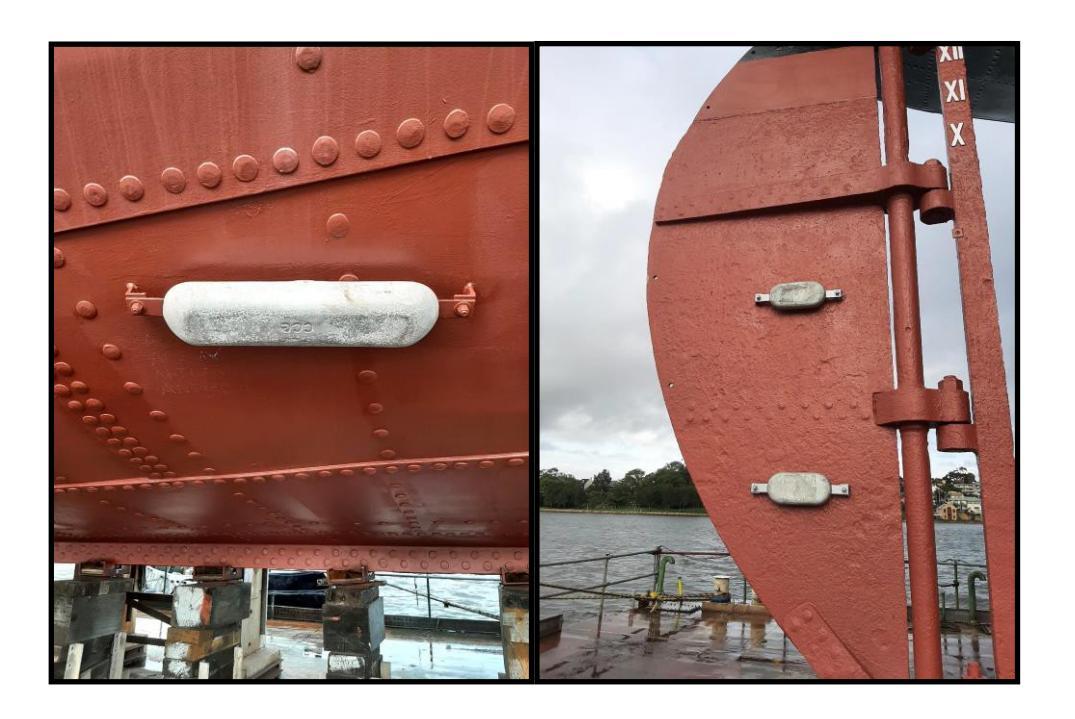
#### Hull anode installed

Rudder anodes installed

One of the last tasks was the selection and installation of anodes – SHF practice is to weld angle brackets to our hulls at a standard distance apart as set by a template. The template is

kept and is brought out of stores to drill new anodes. These are bolted to their brackets as the last antifouling coatings were applied. The advantage here is that future replacements can be carried out by divers and expensive dockings are avoided.

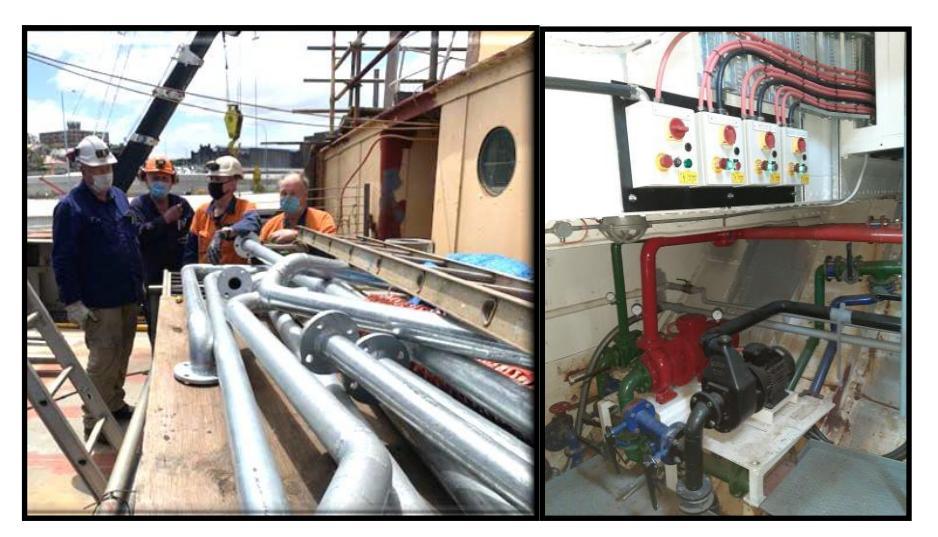
The original bilge and fire piping was corroded, and an entirely new system in steel pipe was needed before refloat. New steel pipe lengths were cut and tack welded to bends and flanges in location. Pipes were then carried out on deck and full welded. When a trailer load of pipes was collected, they were sent out to be hot dip galvanised. We are grateful for the support of Nepean Galvanising for their sponsorship here.

Bilge pipes just back from galvanising New pipessystems installed and painted

Final task then is to install these new pipes and commission the system. One of our lady volunteers has taken on the task of painting inside *John Oxley* and all pipes are now correctly colour coded to match their intended contents.

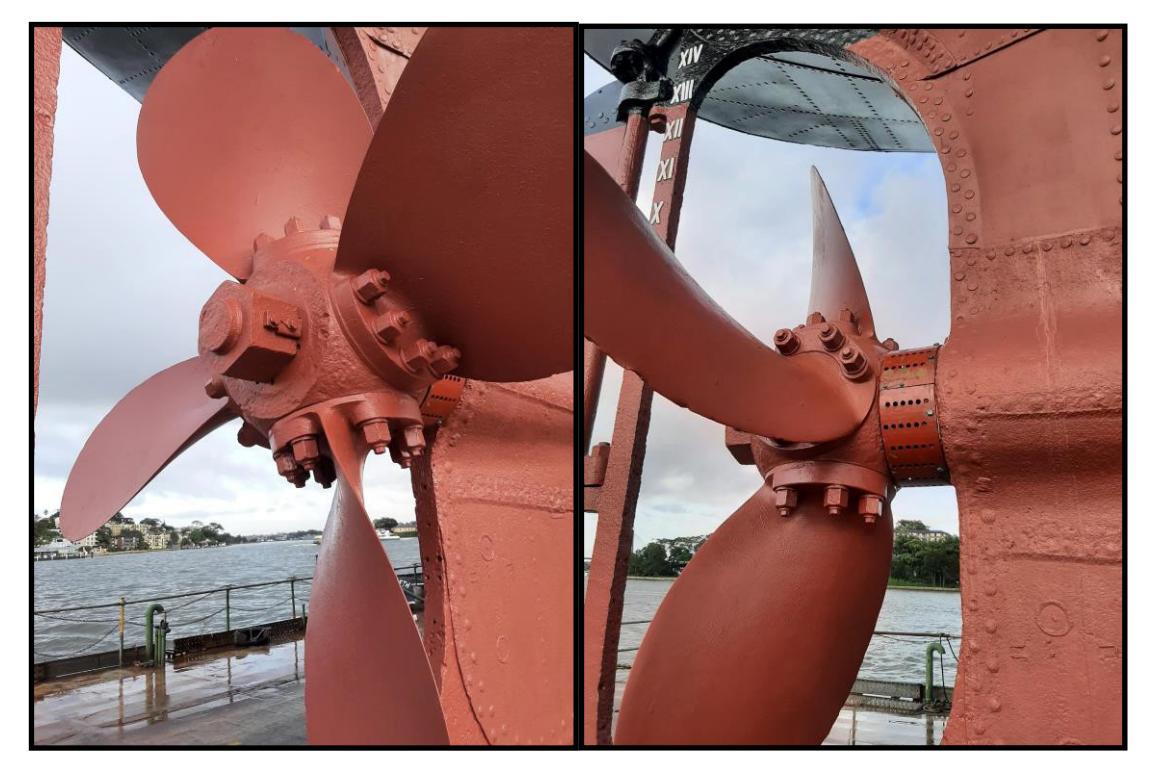
Stones propeller showing hub and blades

Propeller showing rope guard around seal

A Wartsilla propeller shaft seal was installed to the aft end of the propeller shaft and bears up against a machined cast iron pad on the propeller post forging. A sponsor generously provided this seal and it was installed by our team. This type of seal is preloaded to a specified number of millimetres and our engineers set this amount on propeller hub installation.

*John Oxley's* propeller was supplied by the Stone company, which still operate from the UK -This propeller is unusual and consists of a cast iron hub with Manganese Bronze blades bolted in place. The hub had already been sent out for proof machining and was installed

after the seal. The team installed the blades and then adjusted the pitch of each blade to the original setting.

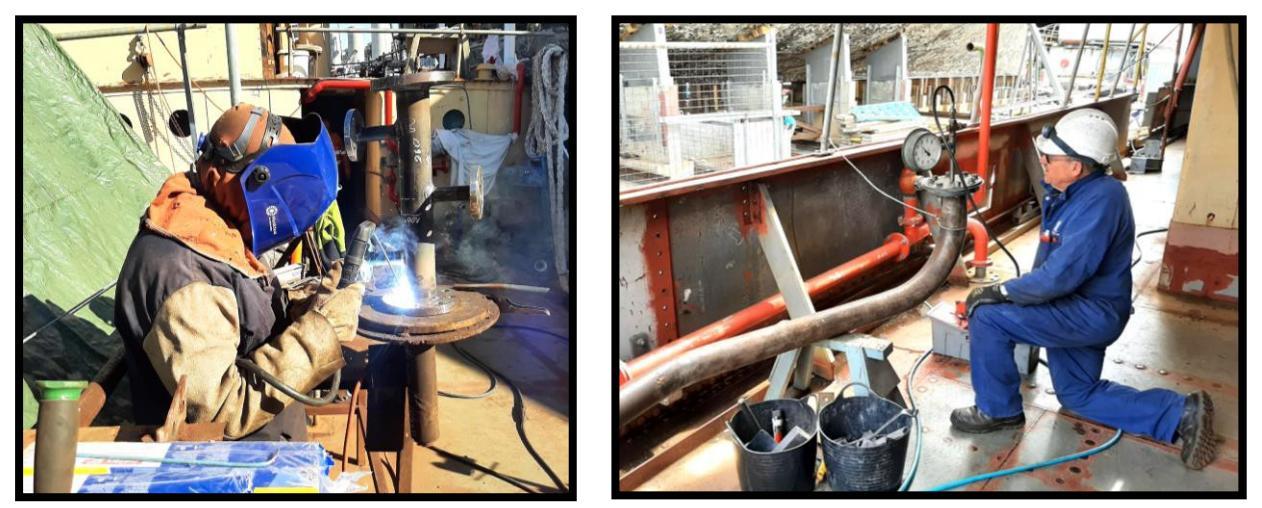
Some carried over work has included the steam pipes. The 1927 copper steam pipes no longer comply with current codes and steel pipes are required. We are fortunate to have the services of NSW Pressure Vessel Inspections, who handle all pressure vessel inspections for SHF. We have been careful to continue this relationship as their inspector has a high level of experience with riveted boilers – We clearly cannot postpone this work. There are also time restrictions on pressure welding qualifications and our engineers are pushing to get all new steam pipes welded by our fabricators in this time frame allowed. This does take our welders off *John Oxley's* Anchor Deck plating, but we expect most steam pipes will be welded, pressure tested and inspected early in 2023.

Welder Raj on steam pipe work

Engineer Malcolm pressure testing steam pipe

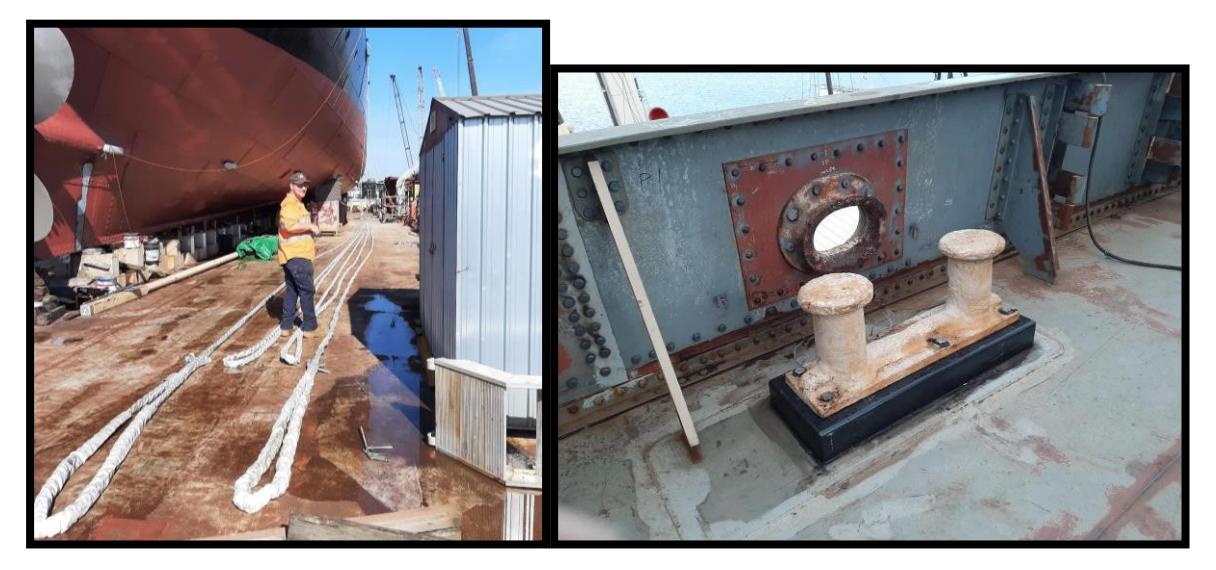
Rigger Tom laying out new mooring lines

Well deck bollards set installed

John Oxley's original mooring bollards were passed fit for service and were descaled and painted. New hardwood mounting pads were sourced from Griffith from an old hardwood bridge that had been scrapped. These 50 year old Ironbark timbers were seasoned and very hard. The team matched each pad and bollard set with its original location, then drilled the

steel deck beneath, and bolted down each bollard on copious amounts of sticky black sealant.

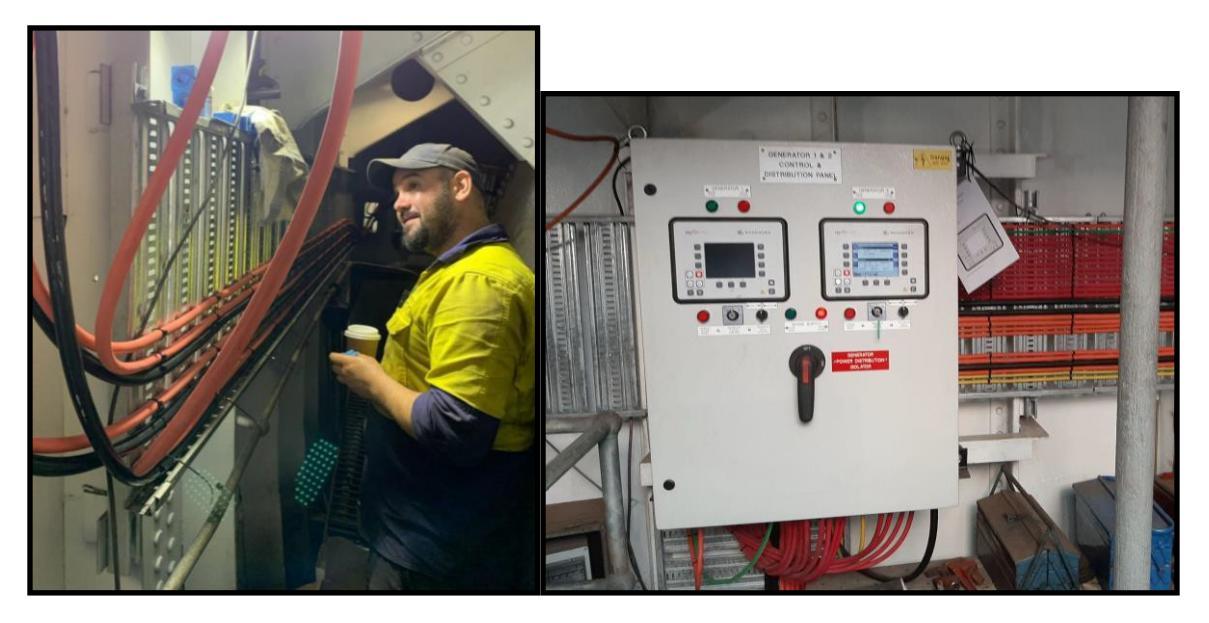
Lead electrician George Toumazis

Gen set switchboard and wiring runs

For refloat, the electric bilge pumps (and fire pumps) would need power. A completed *John Oxley* will have 2 matched diesel gen sets, however, funds were very tight. A generous sponsor supplied one of the 2 gen sets needed and this was purchased and installed by our engineers on the Main Hold Tween Deck.
