# **JOHN OXLEY REPORT - END 2022**

2022 has been a huge year for the *John Oxley* restoration and for the Fleet with very significant milestones achieved. For this report, the most important was clearly the refloat of *John Oxley* at Garden Island Dockyard.

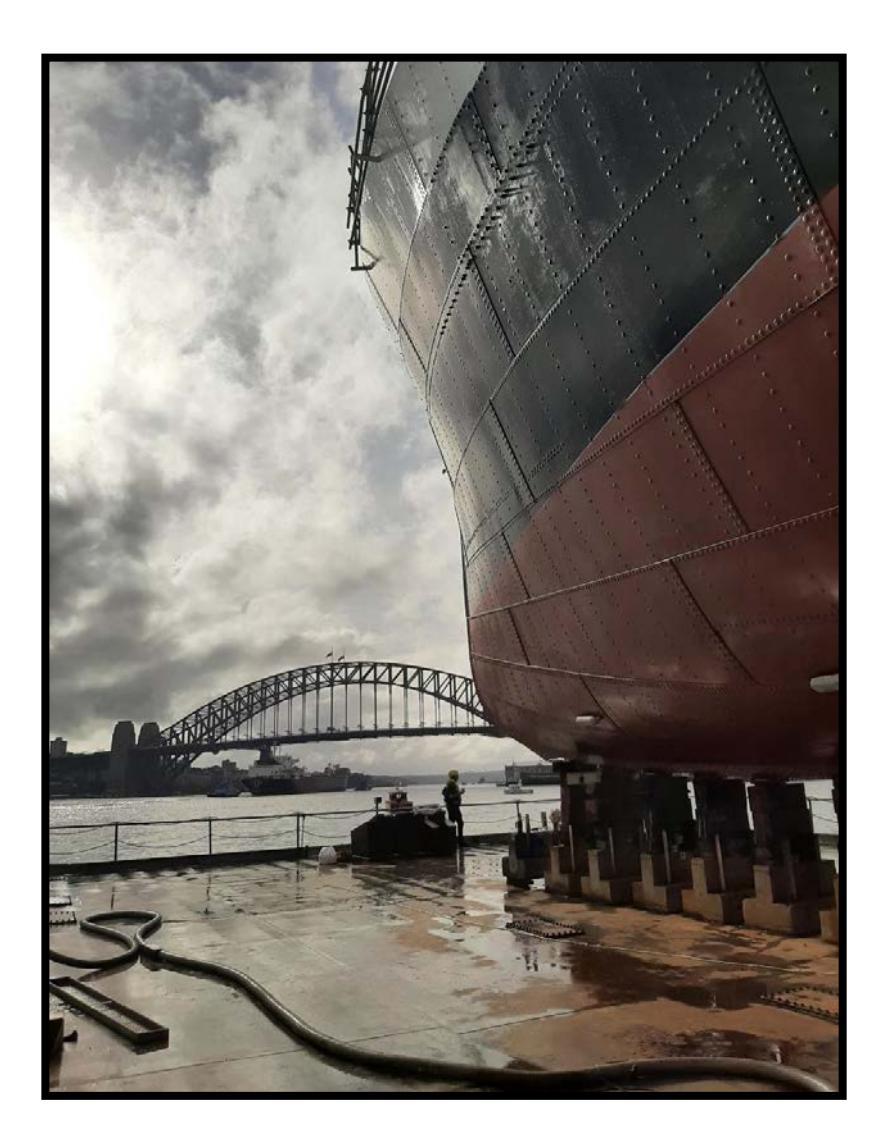
The John Oxley on the Sea Heritage Dock being towed over to Captain Cooks Dock to be relaunched. A milestone for the SHF Team and all the sponsor that have supported this incredible project. Thank you All.

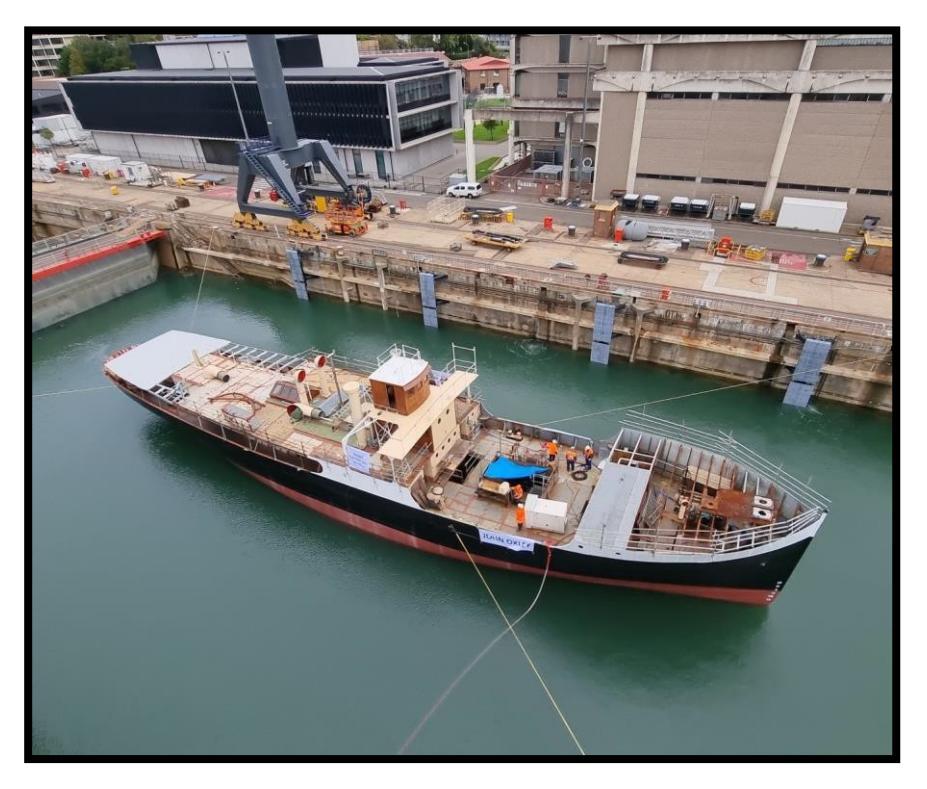
*John Oxley* just after afloat (SHD barge remains submerged beneath on the dock floor)

John Butler Designs provides computer modeling on future weights and stability. JBD worked with Thales naval architects in the dockyard to determine ballasting distribution so that the lightship condition of *John Oxley* would be stable when it refloated from the keel blocks. We had to know when *John Oxley* would float, the loadings on stern keel blocks just before refloat, plus would be any instability issues that could tip the vessel over before the keel aft had left the keel blocks.

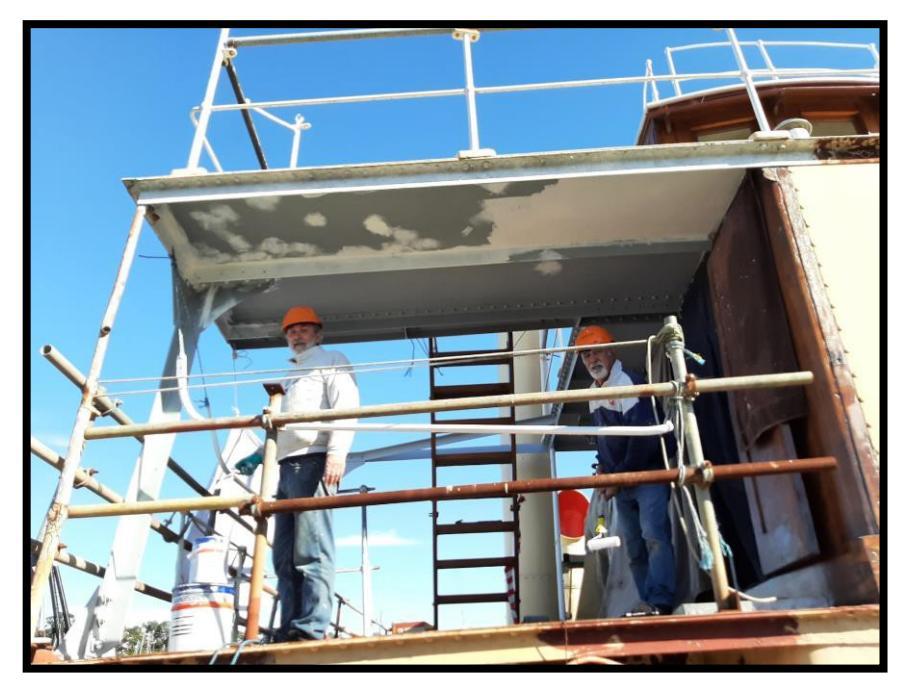
Cabin team applying coatings under Bridge Deck

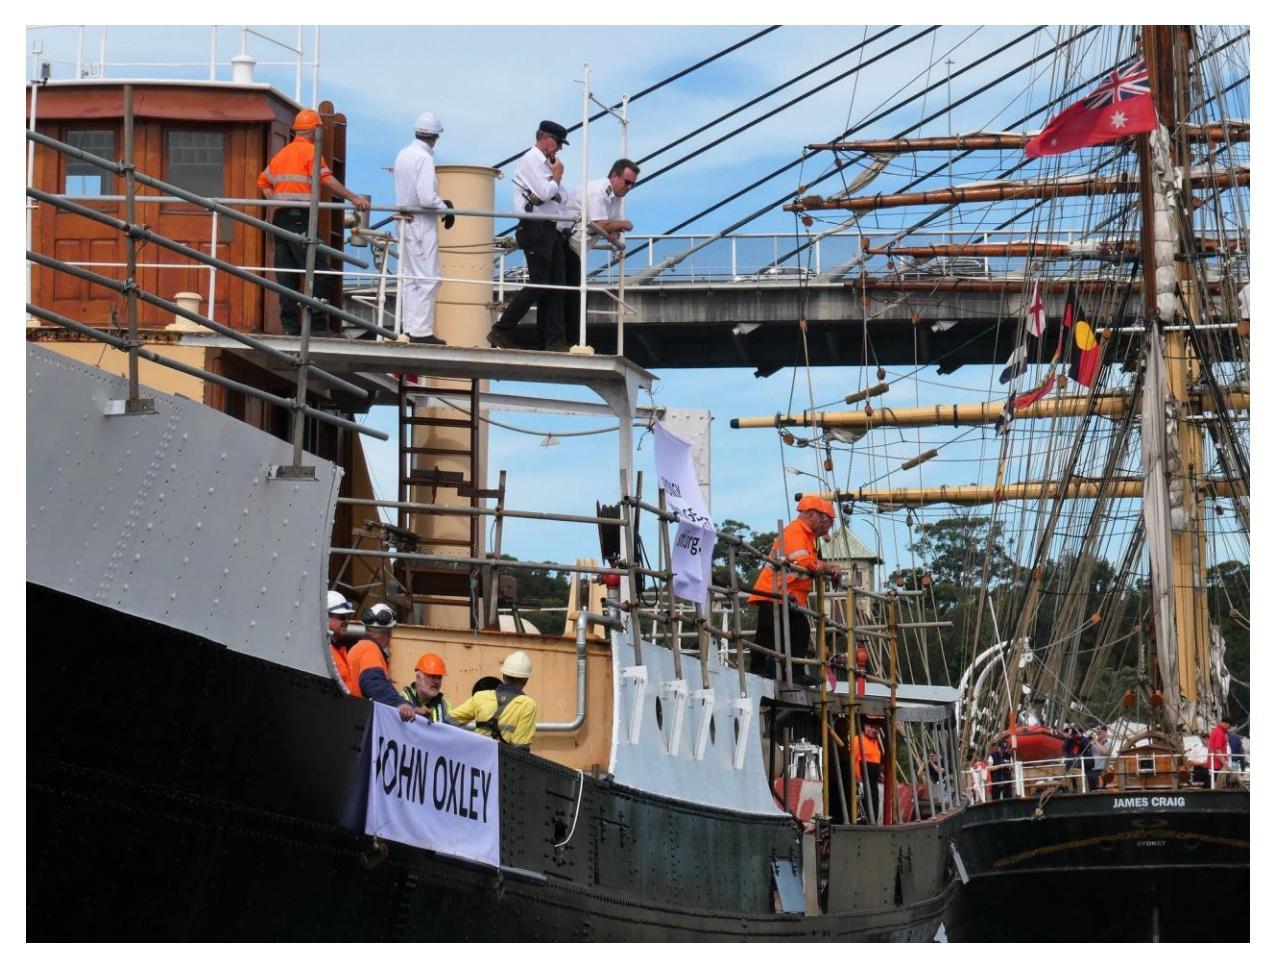
A refloated John Oxley berthing ahead of James Craig

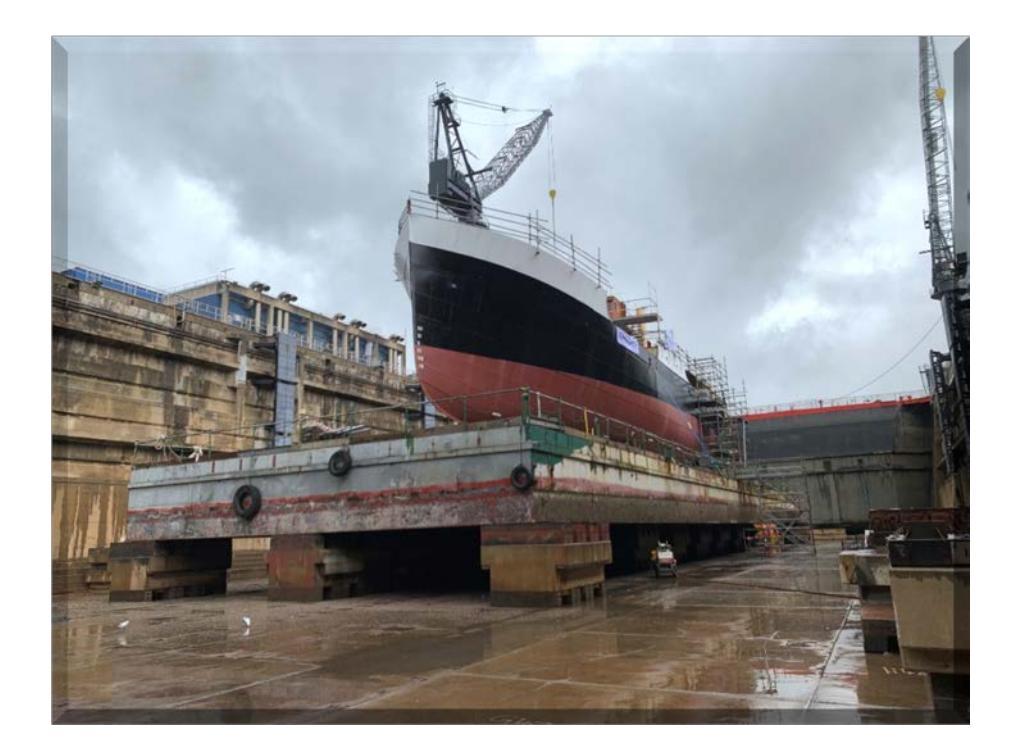
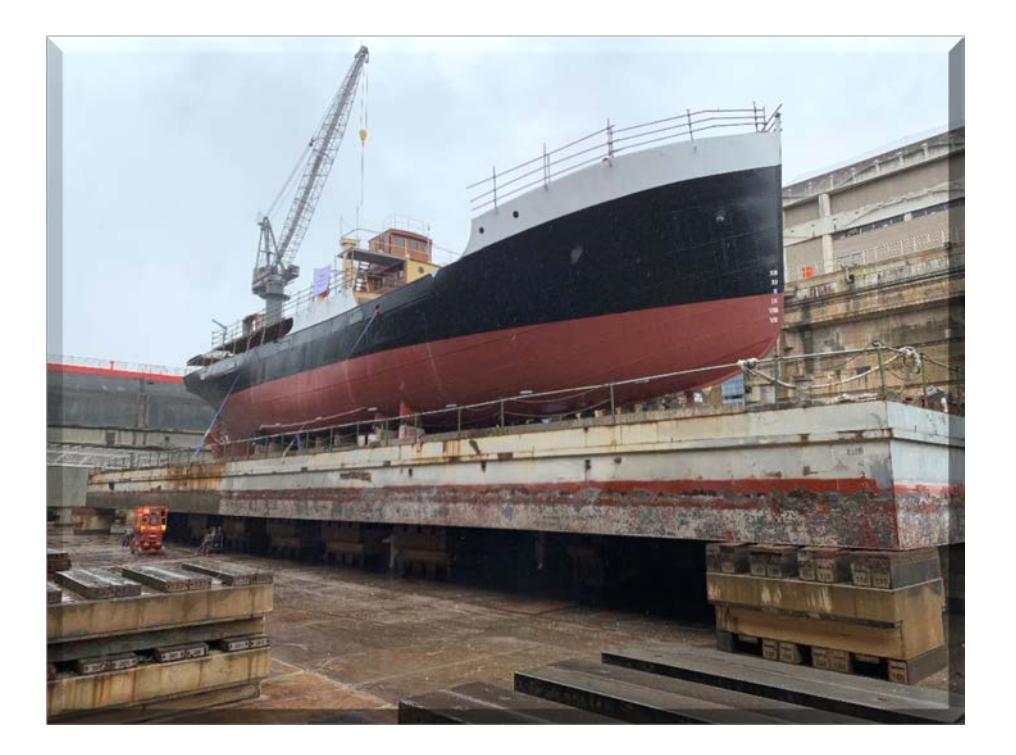
Images above: The Sea Heritage Dock has landed on the bilge blocks in the Captain Cook Graving Dock, Garden Island and the John Oxley is ready to be relaunched once the Graving Dock is flooded.

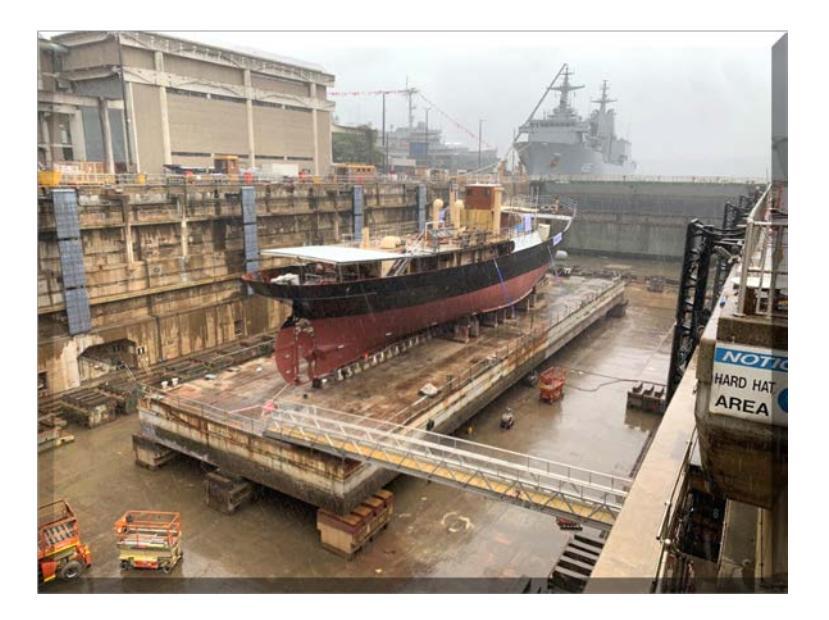
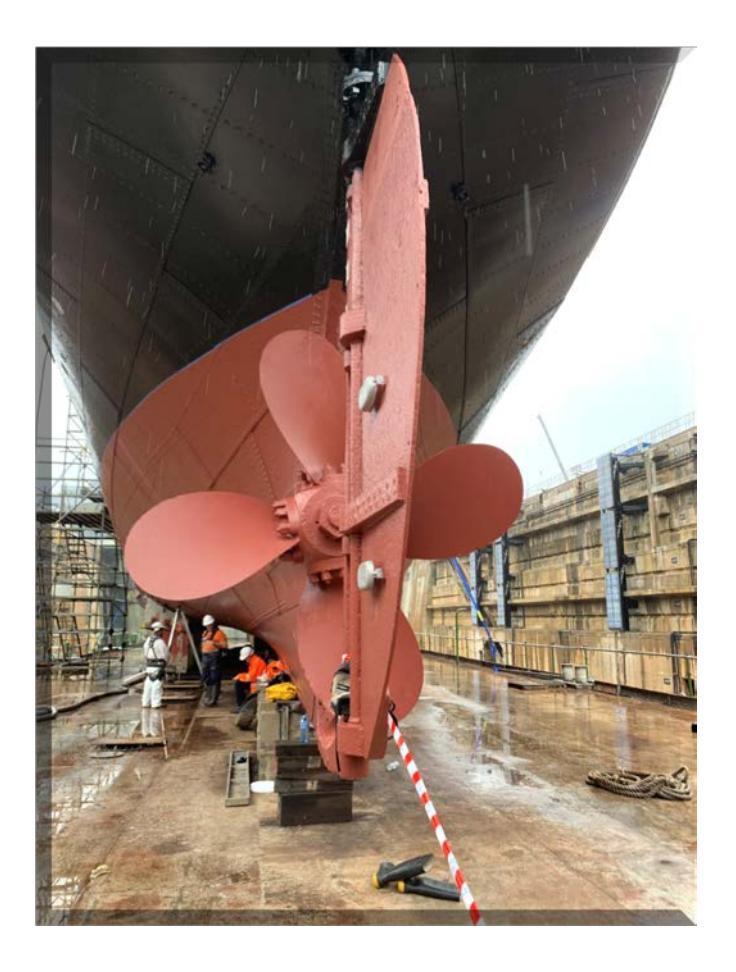
Images above: The Thales Team are removing the Sea Heritage Dock Flooding Ports to allow the John Oxley to lift off (Relaunch) when the Dock is Flooded.

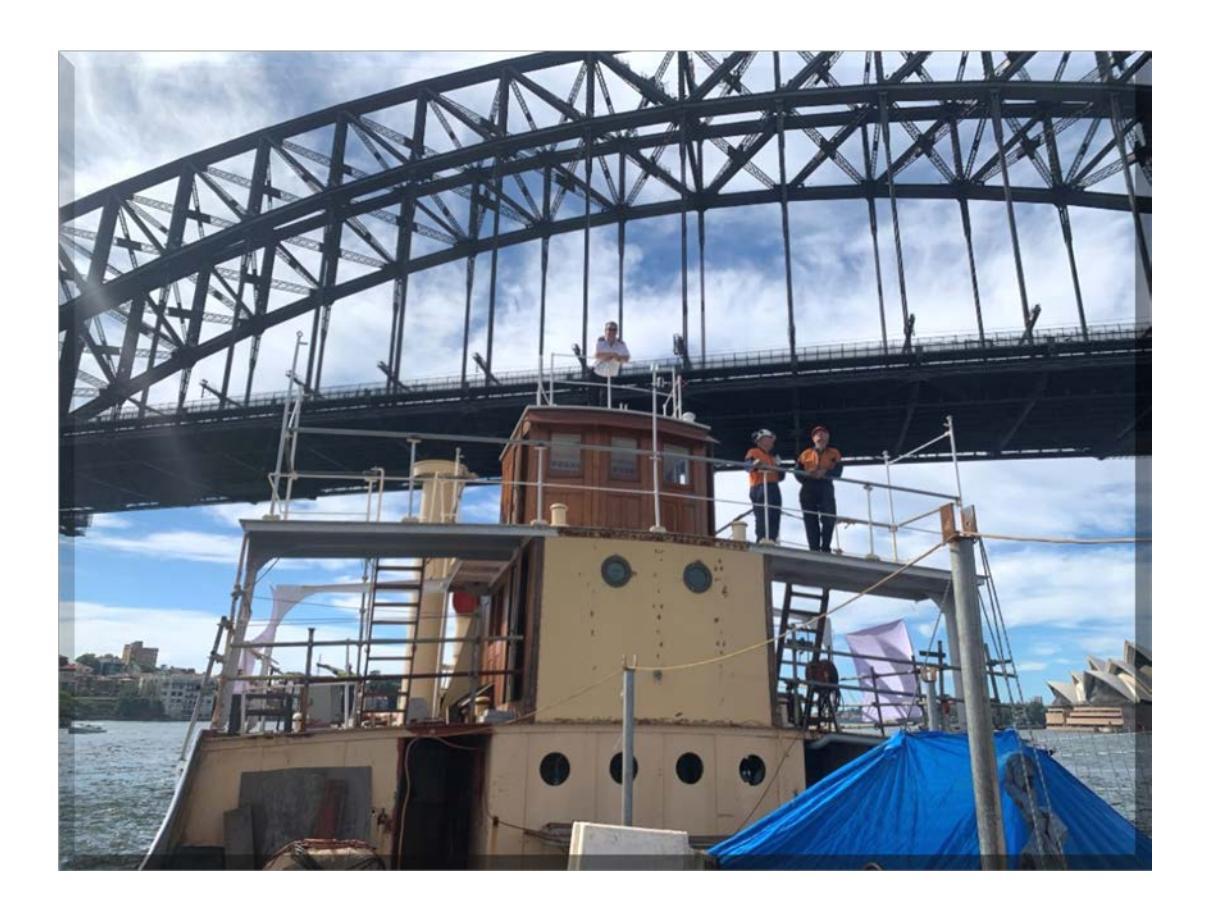
Images above: John Oxley passing under the Sydney Harbour Bridge after the vessel was relaunched at Garden Island. Should note the John Oxley is being pushed by Ausbarge tugs who donated their tugs and crew.
